Repair and upgrading of movable hydraulic steel structures after failures

Ryszard A. Daniel, PhD. Eng – RADAR Structural, Gouda, the Netherlands

Timothy M. Paulus, PE – USACE, St. Paul District, USA

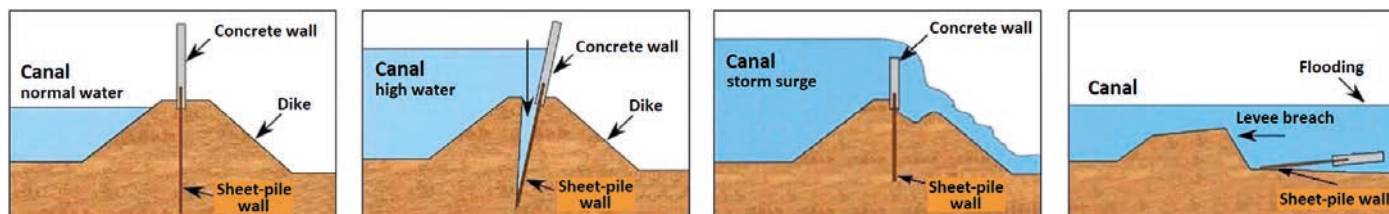
Fig. 1. Typical levee breaches in New Orleans during Hurricane Katrina

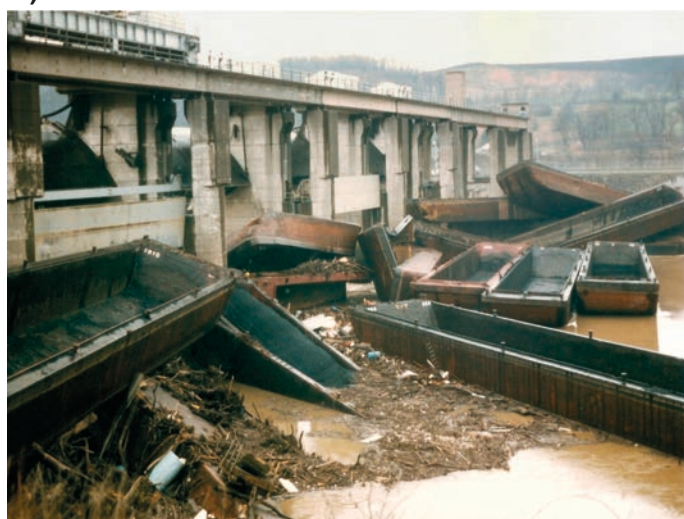
Photo (a) shows the wrecked barges that broke free and jammed against the Maxwell Dam on the Monongahela River Nov. 5th, 1985 during a flood event. The accident halted the shipping for six weeks in order to remove the barges and repair the dam [3]. Businesses were losing \$500,000 each day, because no coal could be shipped on a river dotted with coke plants, steel

a) Monongahela River Maxwell Dam barge accident in 1985, b) miter gate damage at Lock 5a on the Mississippi River in 2013

mills and coal-burning power plants. 5 coal mines were shut and 1,500 miners laid off. This upset event could undoubtedly be classified as a calamity. It was also handled as such by the US Government and USACE; making even part of the hearing by a Congress Committee of Public Works and Transportation [4].

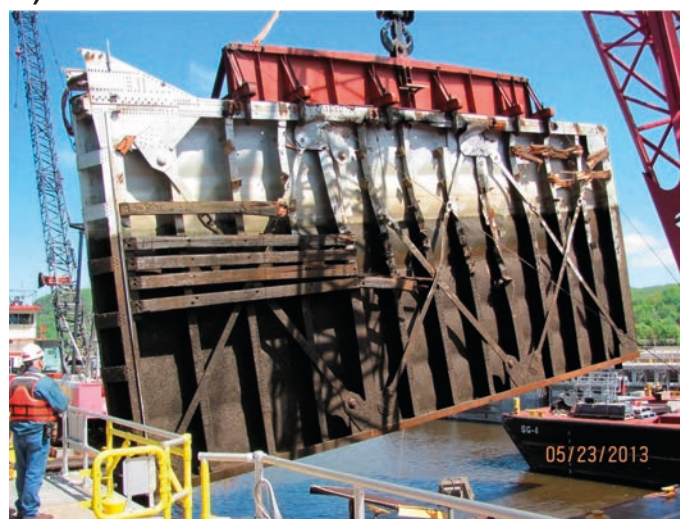
b)

Photo (b) in the same figure shows the damages induced to a miter gate leaf of Lock 5a on the Mississippi River, about 100 km south-east of Minneapolis. On May 16th, 2013, a push-tow barge impacted the upstream miter gate while in recess. This happened in a busy navigation season under extremely high flows. The collision caused damage to the gate but the pool was not lost. There is no second lock chamber at this site, so an extended shutdown would have halted the navigation on the entire Upper Mississippi River. Fortunately, a spare gate was available, and was installed shortly after. The waterway reopened to normal traffic within a week. No formal investigation board was utilized. The removal of the damaged gate and the installation of the spare gate were carried out by USACE in-house forces.

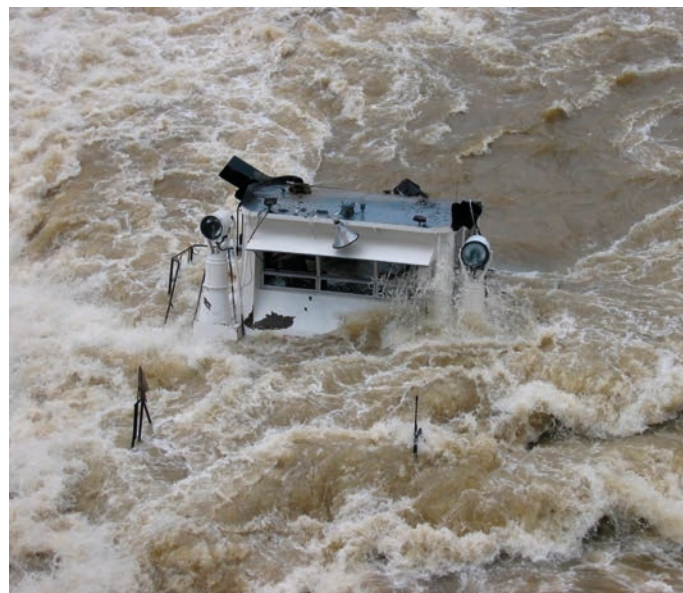
Fig. 3. Elizabeth M towboat after going through Montgomery Dam, U.S. Coast Guard photo by Jesse Garrant

A dramatic example is here the sinking of the towboat *Elizabeth M* that went through the Montgomery Dam on the Ohio River on January 10, 2005 (Fig. 3). Four crewmembers lost their lives in this accident. The course of it is depicted in Fig. 4 and shows how difficult and stressful choices crews can be exposed to. The 2,200 horsepower towboat was pushing a six-barge unit, fully-loaded with coal, when it got caught by the outdraft current while exiting the lock. The current was very heavy due to high water on the Ohio River. To correct the course and save the barges and their cargo, the towboat moved further from the bank and relocated its pushing force. This did not help. The unit was taken downstream by the river, three barges smashed against the piers and blocked the dam bays; and the other three barges including the towboat went through the dam vertical lift gates and sunk on their downstream side. According to the *Pittsburgh Post-Gazette*, “Screams for help echoed from the towboat *Elizabeth M* as it sank into the swirling, frigid Ohio River” [7]. Only three crewmen were rescued from drowning by other towboats.

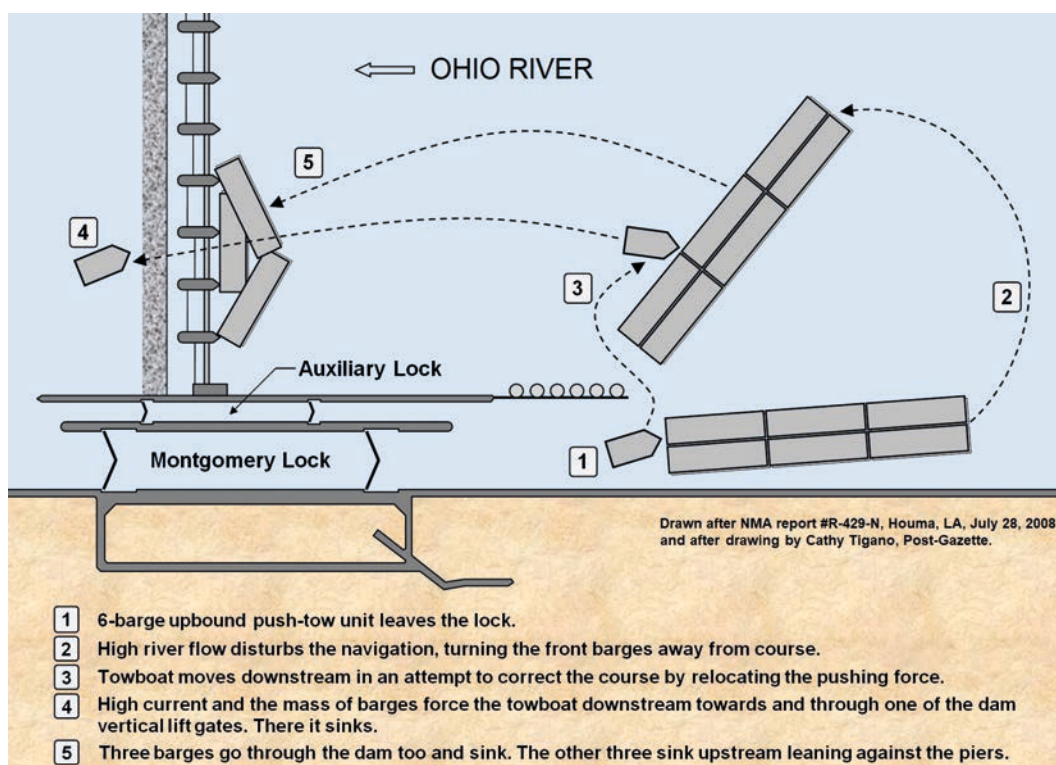
Fig. 4. Course of the accident with Elizabeth M towboat

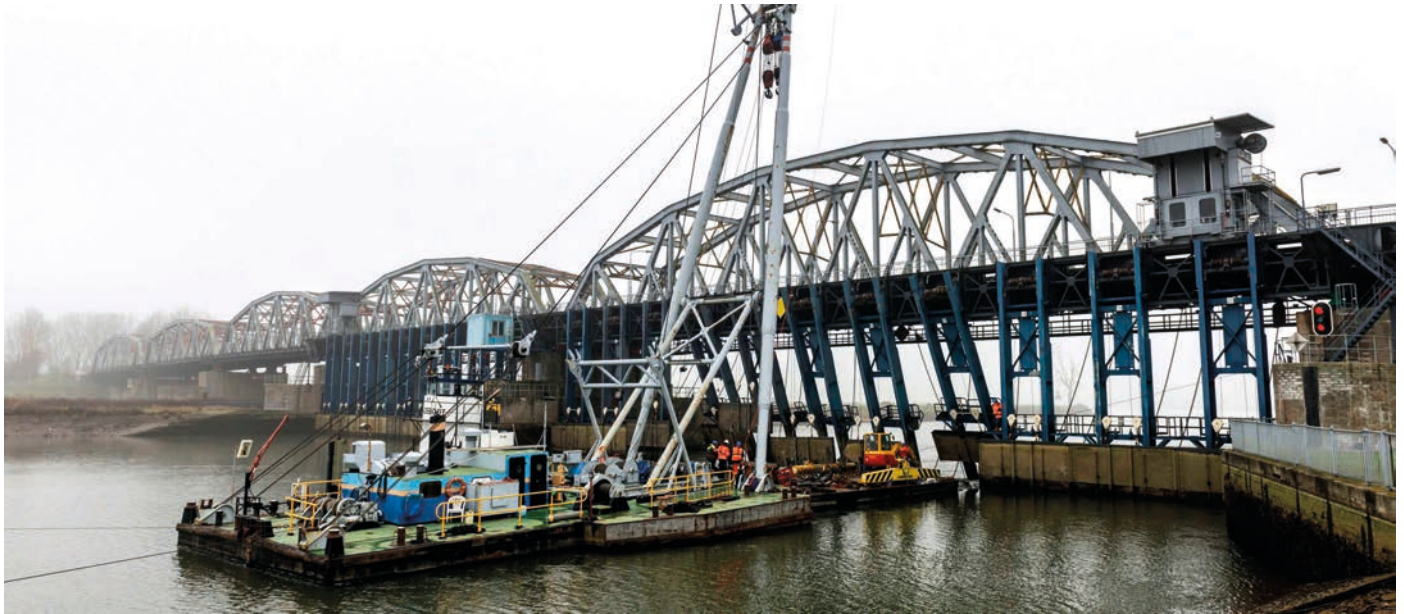
On December 29, 2016, a German downbound tanker *Maria Valentine* carrying 2000 tons of benzene, went through one of the weir spans at full speed. This happened in the morning in a very dense fog. The ship damaged several vertical beams that hang from the bridge to support the water retaining panels. The ship dove down about 3 m passing the weir under the free ends of those beams. This, however, did not cause any injuries or fatalities on board, which was generally considered a miracle. Despite the damage on deck, the crew managed to anchor the vessel downstream of the weir and no benzene leaked into the river. Nevertheless, the damage to the water retaining structure (Fig. 6) in combination with too late closures of weirs in lateral canals caused the loss of navigation and substantial other damage in wide area.

Fig. 6. Damage to the Meuse bridge-weir in Grave, photo Rijkswaterstaat

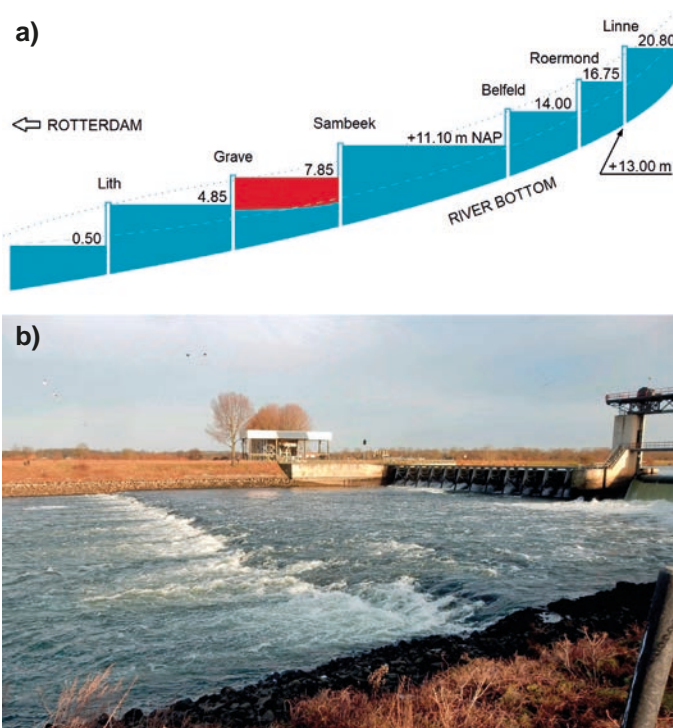
Fig. 8. Loss of upper pool as result of Grave Weir accident in 2017
a) navigation profile of the Meuse River in the Netherlands,
b) Meuse Weir in Sambeek with lost downstream pool, photo Rijkswaterstaat

Meuse River and its lateral canals were not entirely and not soon enough clear for the crisis team. The most evident consequence, the loss of the upper pool, is depicted in Fig. 8. There is a lot that went wrong in both the assessment and the management of the accident. The details of it are described in the report by the national Investigation Council for Safety (Onderzoeksraad voor Veiligheid) [12] along with appropriate recommendations and lessons learned.

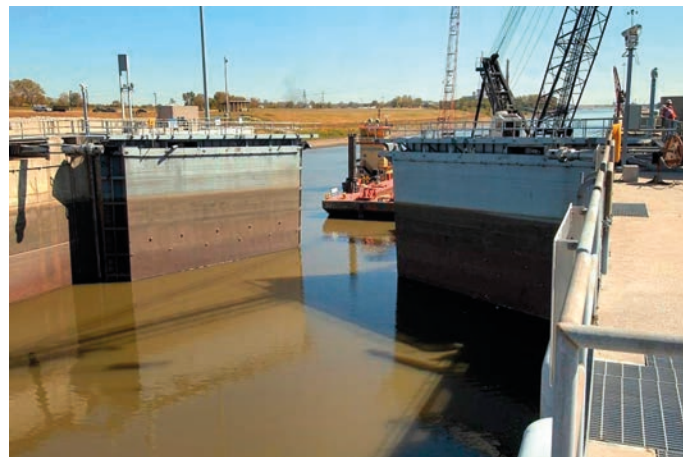
On October 3rd, 2004, both leaves of the auxiliary lock downstream miter gate were forced past their mitered position (Fig. 10), resulting in extensive damage to the leaves and various other damages in the vicinity of the gate. The failure prompted an investigation board and emergency measures to get the lock

Fig. 10. Mel Price auxiliary lock downstream gates after failure, photo USACE

The immediate cause of the failure was the premature opening of the Tainter valves and filling of the lock chamber without the gate leaves being in a mitered position. This created a significant unbalanced head in the lock chamber that subjected the gate leaves, their supports and anchorages to forces beyond their design capacity. The auxiliary lock at this location utilizes mechanical gate drive systems and struts.

Three contributing causes that allowed the chamber to begin filling without the leaves being correctly mitered can, according to [14], be summarized as follows:

- Incorrect indications of Programmed Logic Controller (PLC), identifying that the gate was mitered while it was not;
- No operator verification to check for a successful gate mitering;

- Improper adjustments of hydraulic system relief valve settings, higher than the original design values, resulting in undetected fracture of the gate strut bolts.

back in operation. The gate was repaired by combined effort of USACE in-house forces and contractors. Since the damage occurred to the smaller lock, the large push-tow barges could still use the main lock. However, the failure did create significant traffic delays. The gate was repaired and the lock back in service in July 2005.

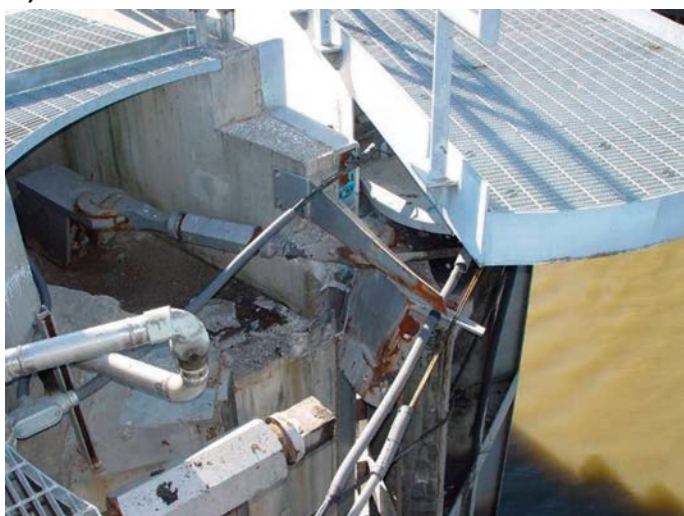
Fig. 11. Mel Price Lock gate failure, details, photos USACE
a) damage to gudgeon anchors, b) damage to the pintle

The failure resulted in an extensive damage done to the gate gudgeon anchorages, as shown in photo (a) of Fig. 11. The anchorages were essentially ripped off the gate leaves. Also the gate operation struts failed and were heavily damaged. The pintle socket sheared off as shown in photo (b) of Fig. 11. The bottom seals and their supporting structure on both gate leaves were also damaged.

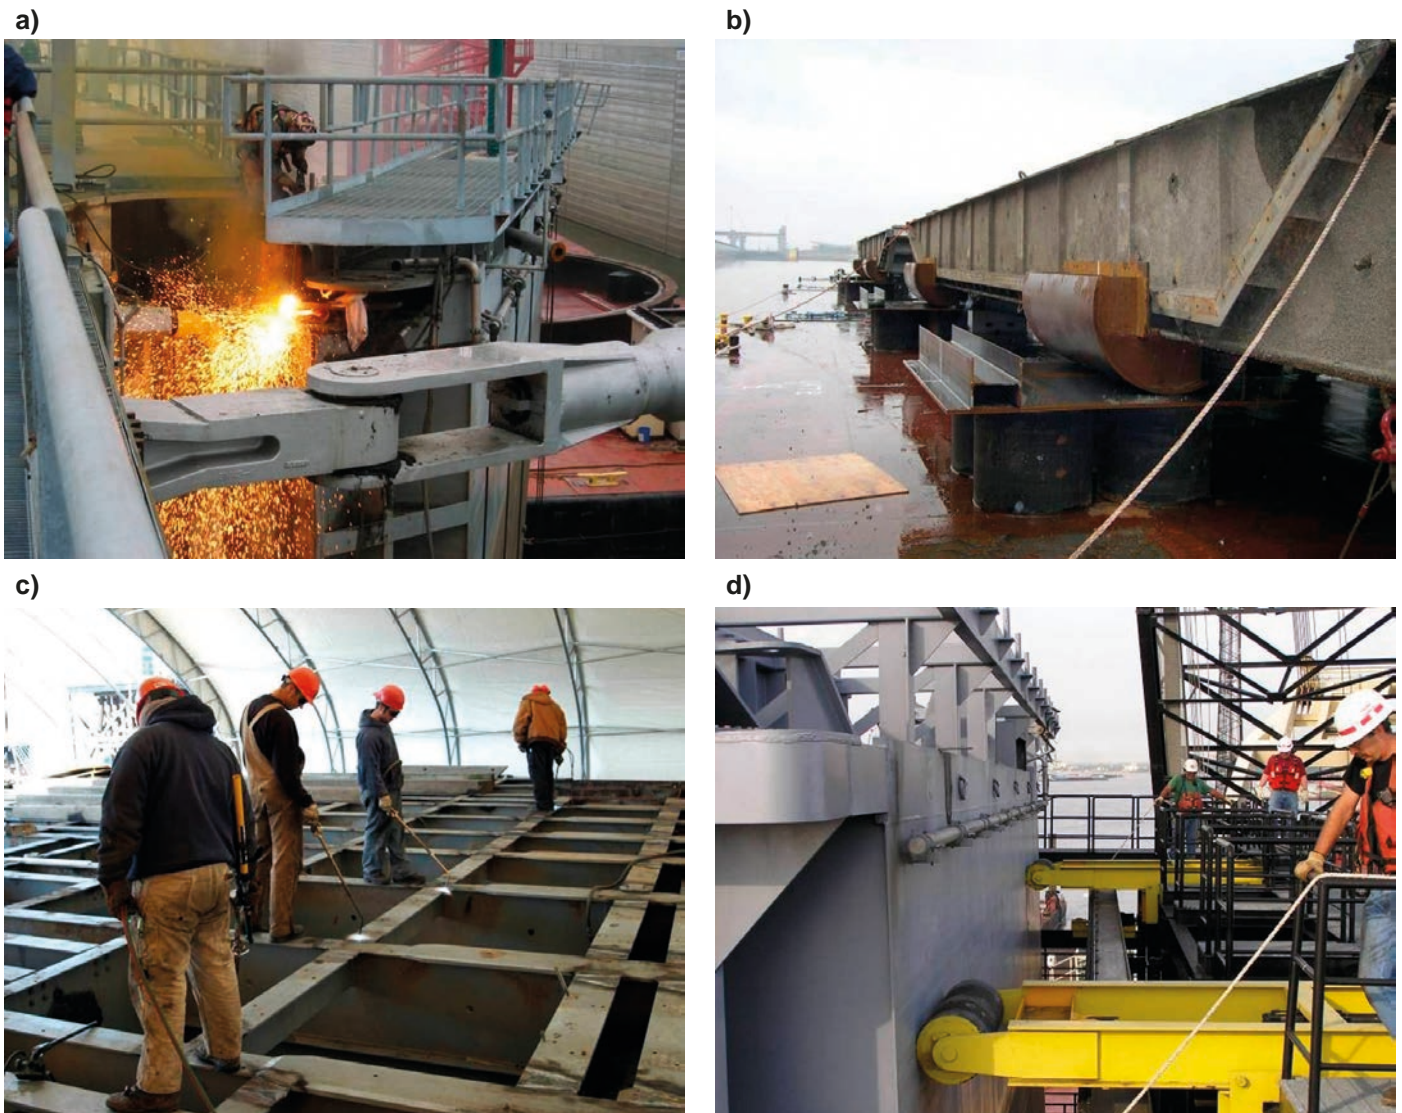
Fig. 12. Mel Price Lock gate, stages of repair, photos USACE

Despite the significant damage, investigations performed by the USACE team supported by experts from various universities, heat straightening experts and other specialists, showed that both miter gate leaves could be repaired. The repair was also believed to be quicker than new construction, thanks to the engagement of USACE in-house forces for disassembly, transport and reassembly of the gate. The gate leaves needed, however, to be shipped to the service base, where they would undergo complex heat straightening, replacement of hinges, anchor bars, struts and other damaged components.

Photos in Fig. 12 present some subsequent stages of this repair. Note that such works require utilization of diverse auxiliary structures, like hoisting beams (so-called “spreaders”), tilting supports, temporary supports and the like. The tilting supports (also called “turning feet”) prevent local dents by spreading the contact pressures that would otherwise have to be carried on the gate edges. The USACE maintenance forces also have vessels that allow gate leaves to be shipped in a vertical position, in the so-called “toasters”. This is particularly desired when the installation of new or refurbished gates must be quick in order to hinder the navigation as little as possible. It also allows to perform some inspections and finishing works while during the shipment of the gate.

- a) gate leaves freed for transport by cutting the anchors, b) gate leaf placed on barge using turning feet, c) heat strengthening of gate girders, d) coated gate leaf in a “toaster” ready for shipment back to the site

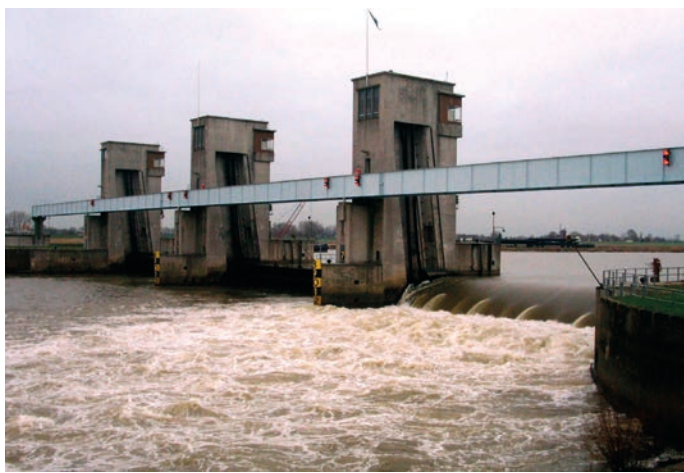
At the end of January 2007, the southern gate of the Meuse weir in Lith, the Netherlands, suffered a serious damage. The top flap section – meant to control the river flow – broke off from its hoisting chains and fell down on the rear structure of the bottom section. The accident caused an uncontrolled flow (Fig. 13) threatening the navigation on the river, which is one of the Europe's most navigated inland waterways.

The failed gate was clamped in a slightly inclined position above the sill. Setting it stable on the sill was the first goal and was accomplished the day after the accident. The next steps required the installation of an emergency closure on the upstream side, which, however could only be done at reduced flow over the gate. This was not easy since the calamity happened in the period of high flows. Yet, the upstream water level could temporarily be lowered by adjusting the upstream weir heights and allowing for more discharge through lateral canals. At the same time, the downstream water level could slightly be raised. This reduced the river flow in Lith, which, in turn, allowed to temporarily lift the other two weir gates out of water. The result was a still further local equalizing of water levels at both sides of the failed gate. Under these conditions, the emergency closure

Fig. 13. Uncontrolled flow as result of Lith Weir gate damage

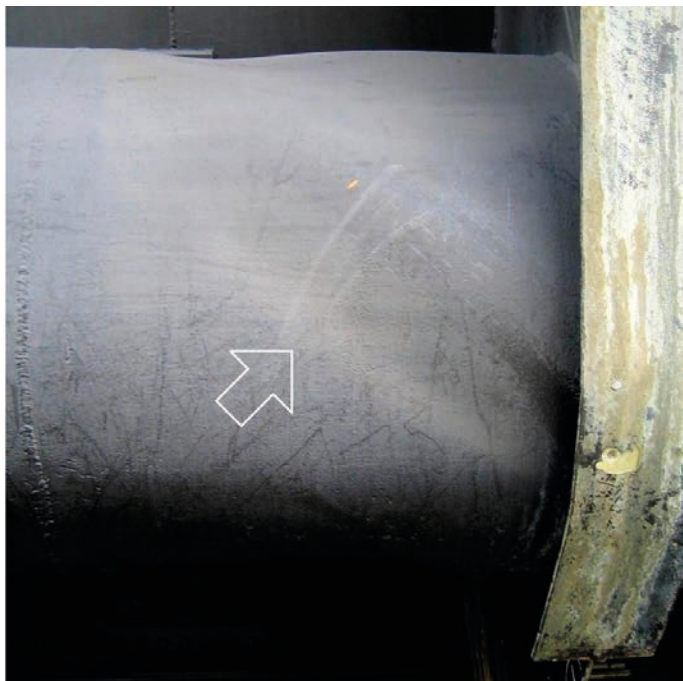
Fig. 14. Lith Weir gate damages, details, photos Rijkswaterstaat
a) deformed torque tube of the flap section, b) fractures of flap lever arm castings
