Repair and upgrading of movable hydraulic steel structures after failures

Ryszard A. Daniel, PhD. Eng – RADAR Structural, Gouda, the Netherlands

Timothy M. Paulus, PE – USACE, St. Paul District, USA

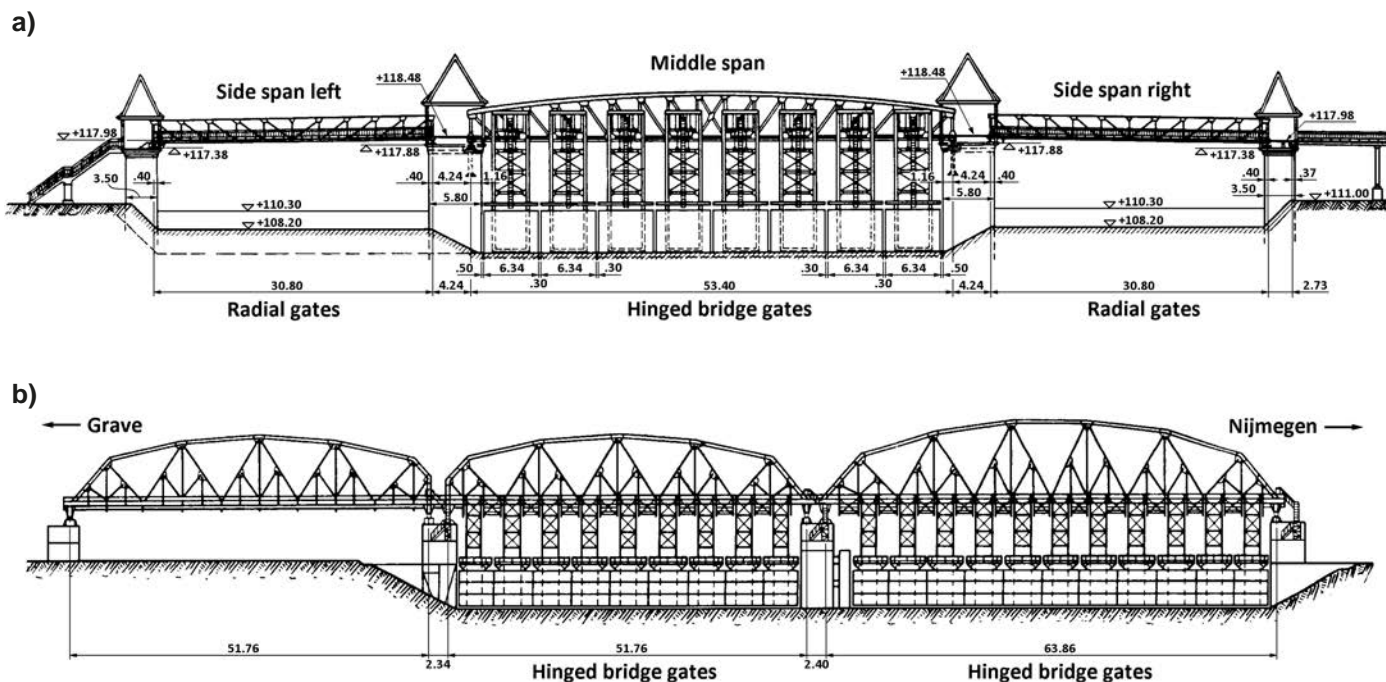
Fig. 5. European “bridge-weirs”, drawn after [8]
a) Oder Weir in Rędzin near Wrocław, Poland, b) Meuse Weir in Grave near Nijmegen, the Netherlands)

Schematic side views of both structures are presented in Fig. 5 [8]. Hydraulic loads are carried here by liftable water retaining panels, supported to vertical beams that, in turn, are hinged to the girders of a bridge spanning above the weir bay. During floods, the weirs can be “folded” by hoisting the beam free ends out of water to the horizontal position under the bridge deck.

On December 29, 2016, a German downbound tanker *Maria Valentine* carrying 2000 tons of benzene, went through one of the weir spans at full speed. This happened in the morning in a very dense fog. The ship damaged several vertical beams that hang from the bridge to support the water retaining panels. The ship dove down about 3 m passing the weir under the free ends of those beams. This, however, did not cause any injuries or fatalities on board, which was generally considered a miracle. Despite the damage on deck, the crew managed to anchor the vessel downstream of the weir and no benzene leaked into the river. Nevertheless, the damage to the water retaining structure (Fig. 6) in combination with too late closures of weirs in lateral canals caused the loss of navigation and substantial other damage in wide area.

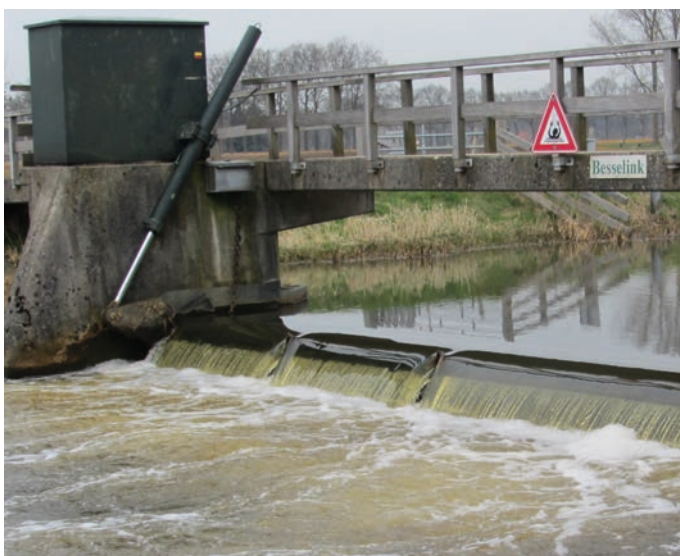
a)

Fig. 7. Prohibition signs for swimmers (a) and boaters (b) at small river weirs

- Overtopping flows generate horizontal currents on the upstream side and vertical currents on the downstream side. They also aerate the downstream water (see Fig. 7a) decreasing its specific gravity and increasing the risk of drowning.

Accidents, including life safety issues, happen not only at large lock and dam sites but also at small river weirs and other structures with hydraulic gates. What increases the risk then is that there is normally no operation personnel at such structures. Therefore, it is important that all possible measures are taken to discourage swimming, boating, fishing and other activities that may generate risks, without changing the structure into a fortress. Hydraulic structures attract public attention and they should continue doing so. After all, openness to the public pays back in local understanding, acceptance and care. The simplest way to discourage risk generating activities is to place signs that clearly prohibit them. Fig. 7 shows two examples of this from small river weirs (one with a fish ladder) in the Netherlands.
